MACKENZIE DELTA AND BEAUFORT COAST SPRING BREAKUP NEWSLETTER

Report **2018-02**

May 14, 2018 (Monday)

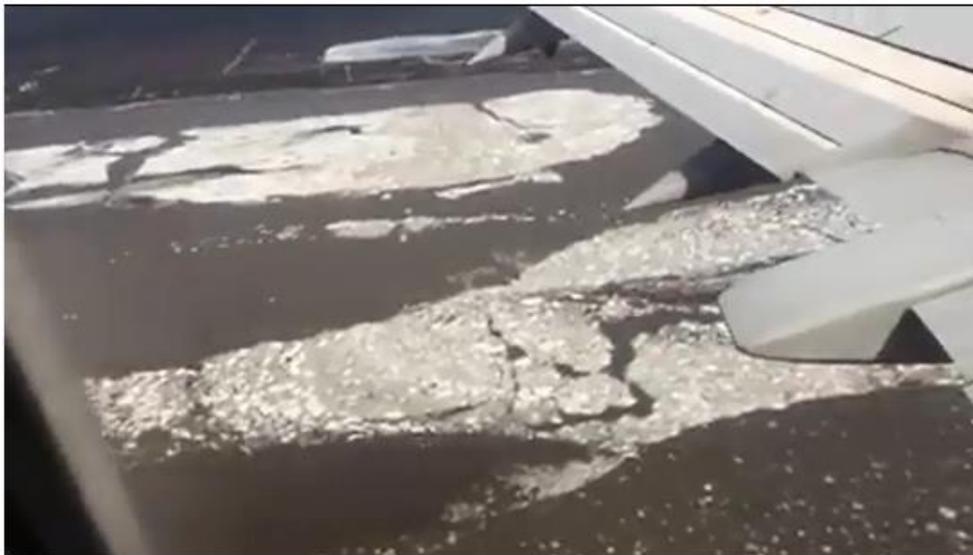
Figure 2. Screen capture from a video showing the ice conditions on the Mackenzie at Norman Wells on May 12. Posted on FB by Jen Lam.

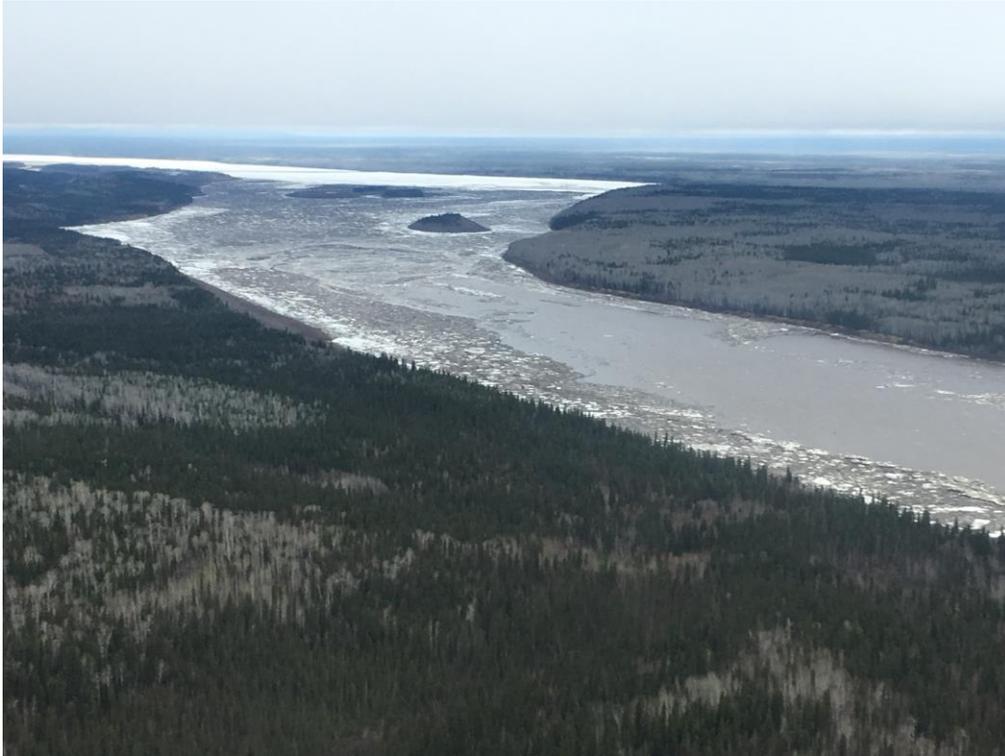
Figure 3. An older image (May 8, 2018) provided by Rod Smith (GSC-NRCan), showing the breakup of the Liard River as it empties in the Mackenzie. Aerial image taken looking NW from Fort Simpson

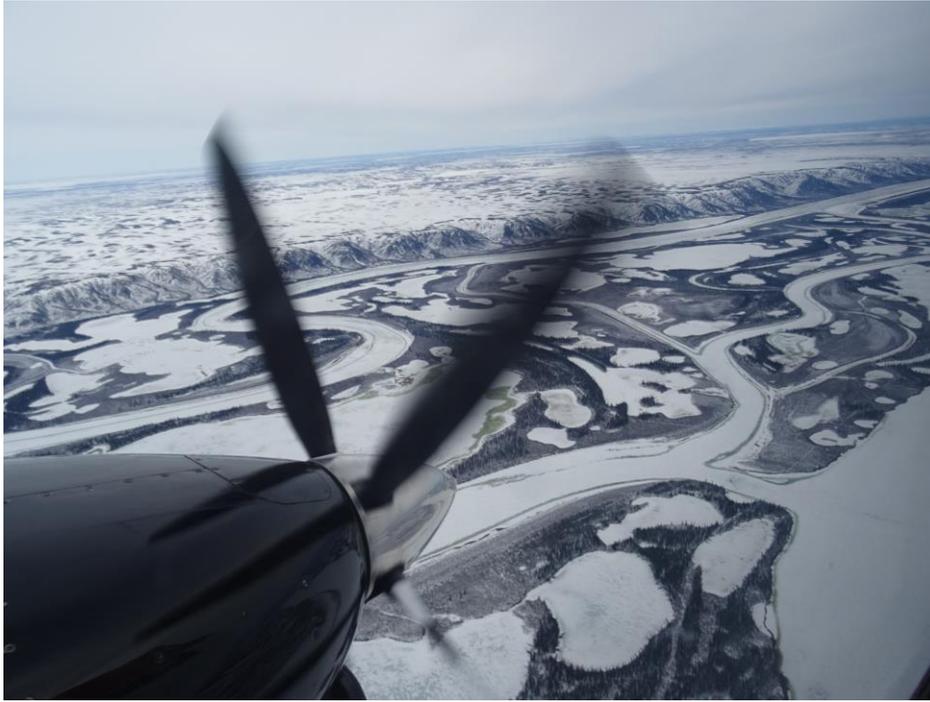
Figure 9. Photo from the Mackenzie Delta, just North of Inuvik on May 12. Visible overflow along the channel edges. Thank You Christian Haas, York University.

Christian Haas proved a great overview shot of the Mackenzie Delta just North of Inuvik, position 69.6865 N, -134.2791 W. A great shot of the initial water overflow happening at the boundary of floating and bottom fast ice along the channel edges creating nice parallel patterns along the shores of the river arms (Figure 9).

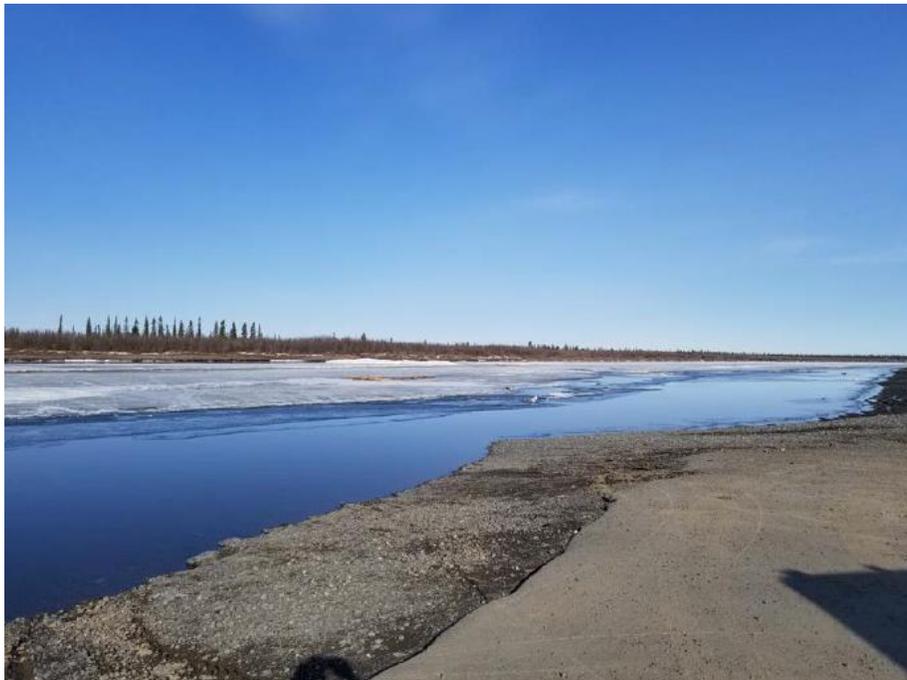
Figure 10. Photo from the town dock in Inuvik looking downstream taken on May 14 by WSC staff.
